NBSIR 80-2100

Thermal Resistance Measurements of A Built-Up Roof System

S. J. Treado

October 1980

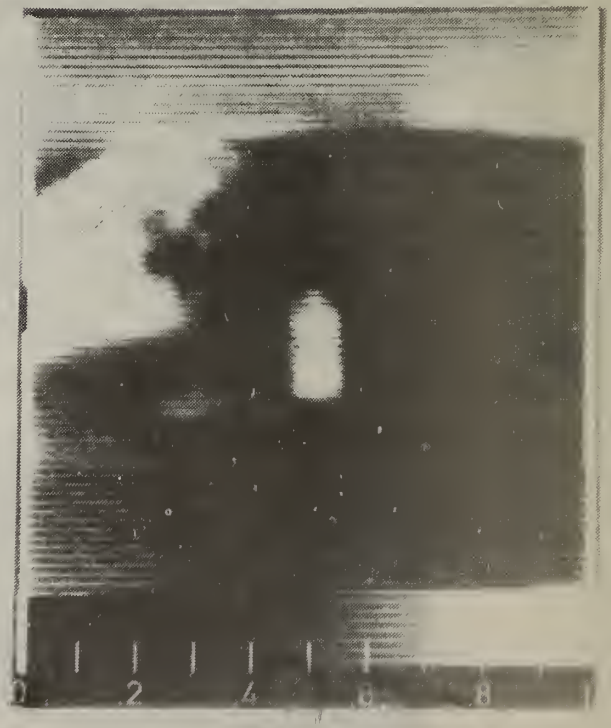
Figure 5. Roof Thermogram at Measurement Location (Location Marked by Cylinder)

The close agreement between measured and calculated thermal resistances for the roof indicates that the thermal performance of the BUR system was as would be expected based on design parameters. Moisture intrusion or other factors affecting thermal conductance were not believed to be present, since the roof thermograms indicate fairly uniform surface temperatures, and since the measured thermal resistance at the warmest spot on the roof showed no reduction from design value.

To investigate the actual moisture content of the roof, samples of insulation and membrane were taken from a location near that of the thermopile. The insulation was fiberglass and was about one inch thick. An exact measurement of its thickness could not be made since it was damaged when cut from the roof. Since the roofing specification called for insulation to have a conductance of 0.24 Btu/h·ft^2·F (1.36 W/m^2·K), it is assumed that the insulation was 1 1/16 in (27 mm) thick. The moisture content of the insulation was determined gravimetrically and was found to be very low, only 0.2 percent.

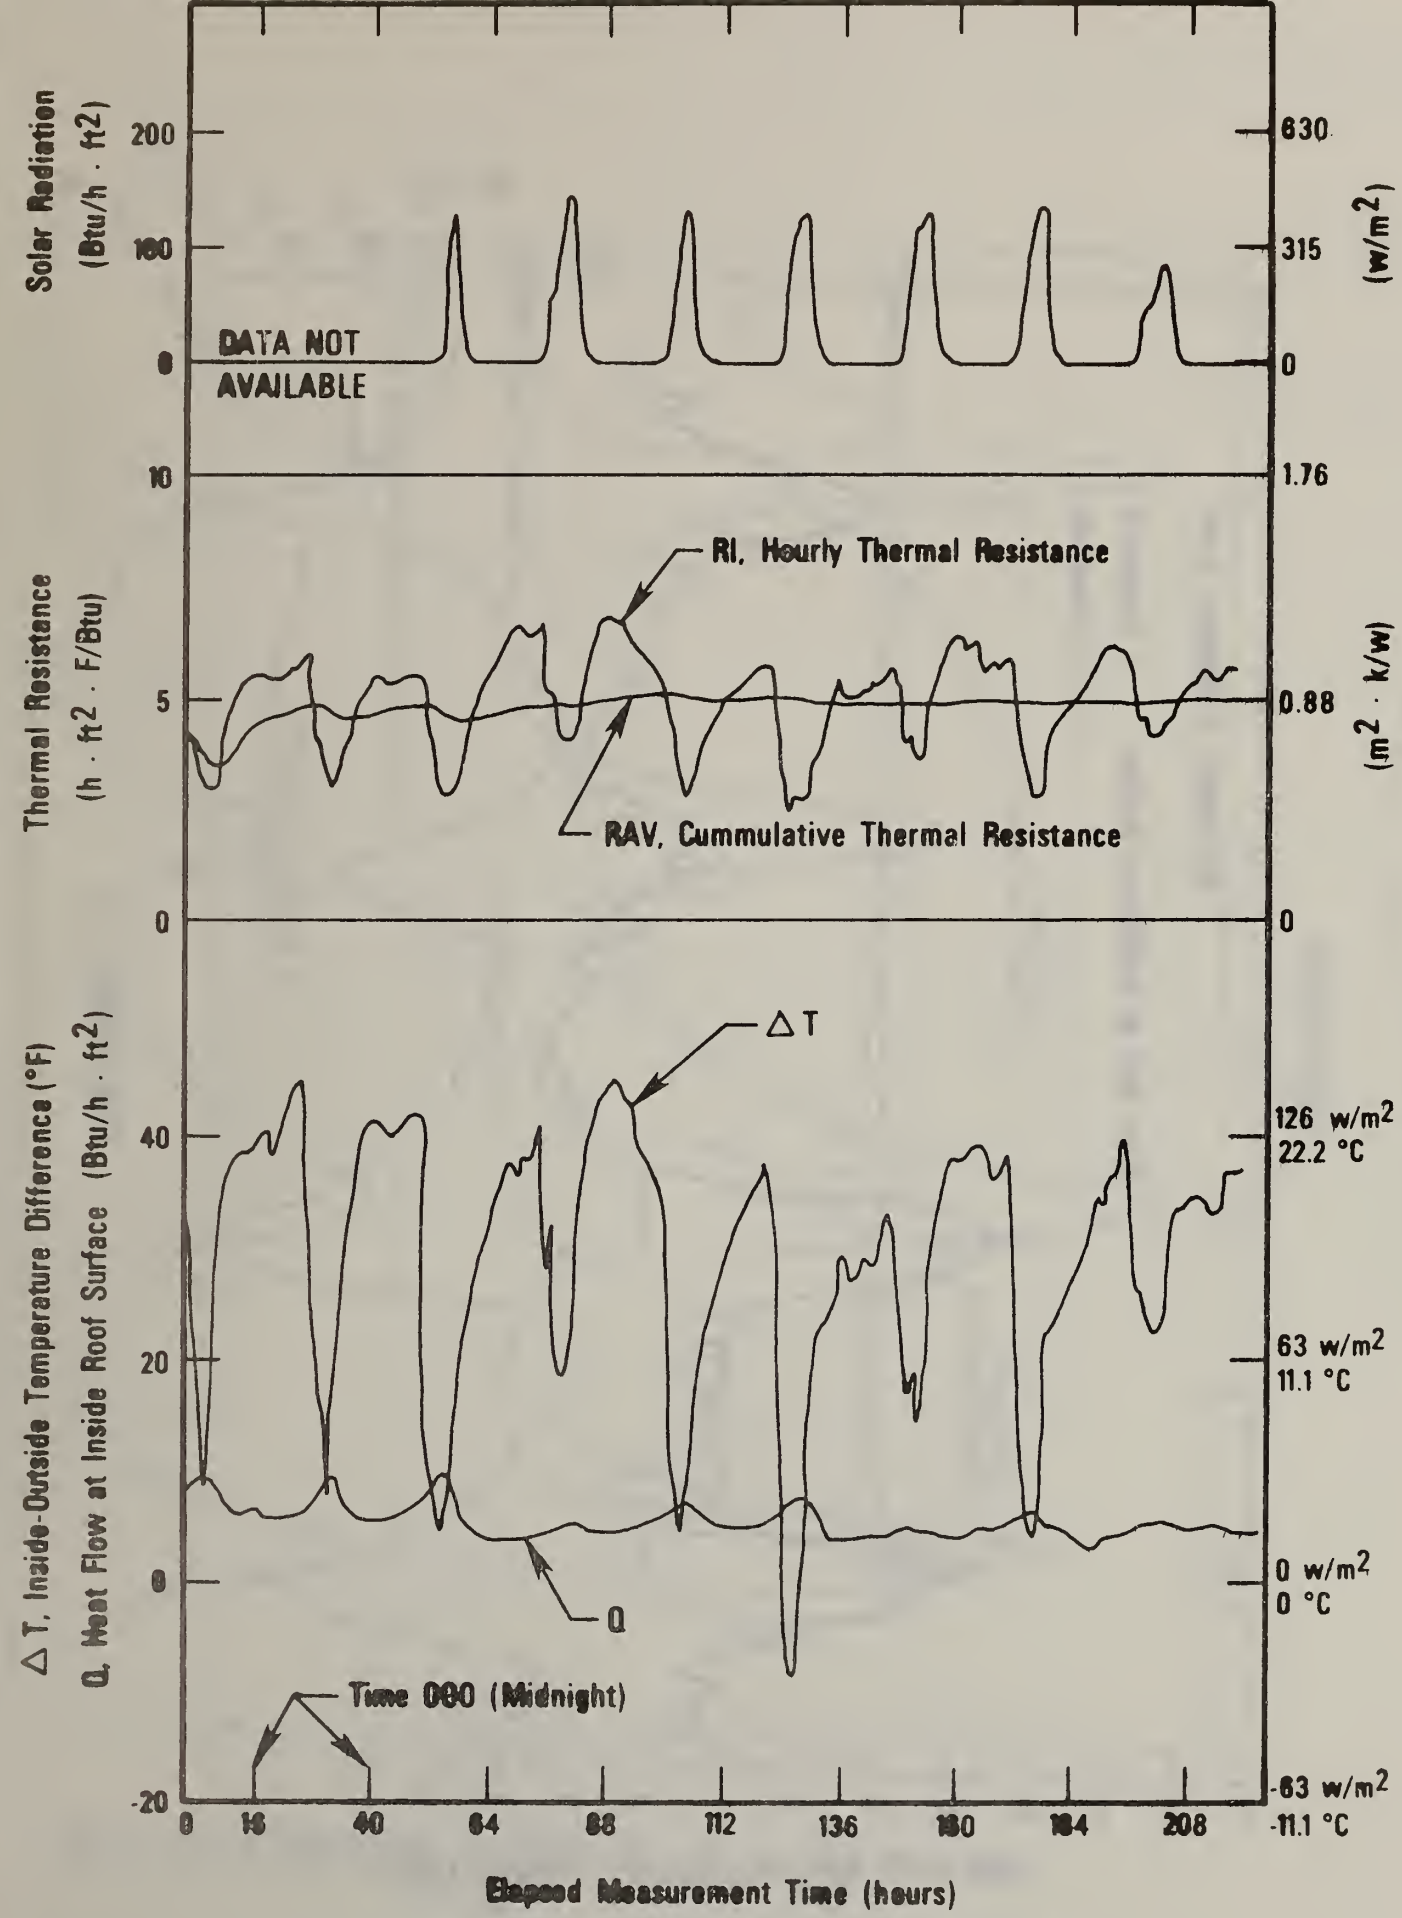
Figure 6. Thermal resistance measurement of BUR system with concrete deck

heat flow in discrete hourly increments. The values ΔT (temperature difference), Q (heat flow) and RI (hourly thermal resistance), are plotted in figure 6 at hourly intervals. RAV, noted in figure 6, is the cumulative average of RI or:

The instantaneous hourly value of the thermal resistance is seen to vary strongly with the temperature difference across the roof. Maximum heat flow is seen to lag behind maximum temperature difference by approximately 12 hours, due to the thermal capacitance of the roof.

The measured overall thermal resistance at this location of the roof was found to be 5.06 $\frac{h \cdot ft^2 \cdot F}{Btu}$ ($0.89 \frac{m^2 \cdot K}{W}$), based on the nine days of measurement. This is 3.3% higher than the design value of 4.90 (.86). The RAV line gives a good example of how long measurements must be made to negate the effect of random daily temperature fluctuations on the average thermal resistance value. After 67 hours of measurement the cumulative average thermal resistance, RAV, stayed within 10% of the final value (5.06 ± .506). After 133 hours, RAV stayed within 5% of the final value (5.06 ± .253). These time factors would vary according to roof type and temperature conditions, but for roof of this type, three to six days of data collection would be necessary to obtain a representative value for the thermal resistance. The time required for cumulative averaging will vary from one roof to another depending on the thermal capacitance (thermal mass) of the roof. Shortening this time span could result in inaccuracies due to random fluctuations or variable daily temperature cycles.
